Addition of signs to existing historic Vann Tower.

### Virginia Union University VANN TOWER

+ VANN TOWER SIGN PRESENTATION + ERIK BOOTSMA ARCHITECT + WWW.BOOTSMADESIGN.COM + 2022 +

Four (4) 295.2-square-foot, lighted signs, in the shape of VUU's logo, attached to the exterior of the 165-foot tower (a.k.a. the Vann Tower)rising from the center of the Belgian Building, one sign on each of the Belgian Building's four sides.

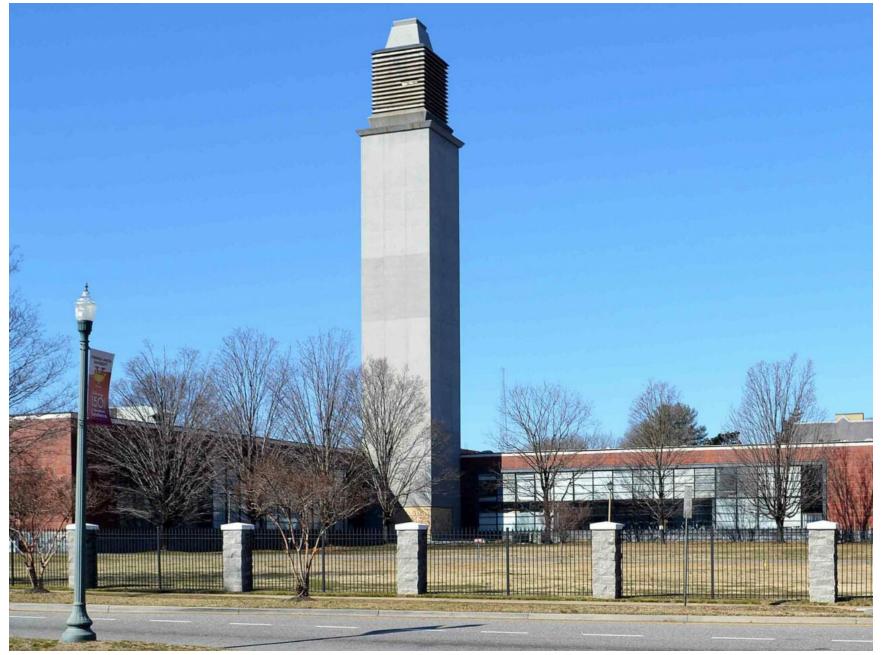
View of Vann Tower before sign installation (DHR)

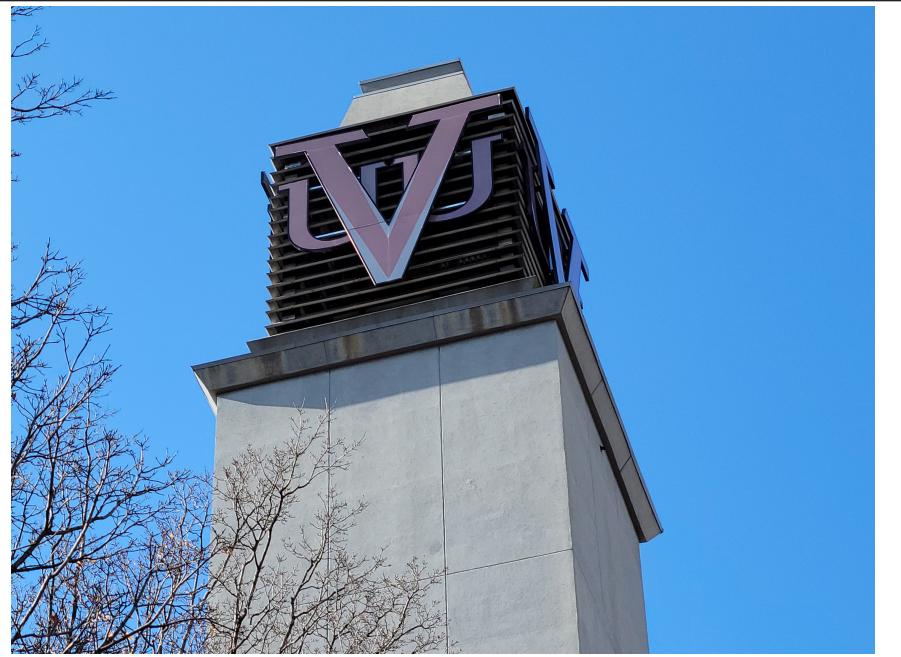
Southeast Detail

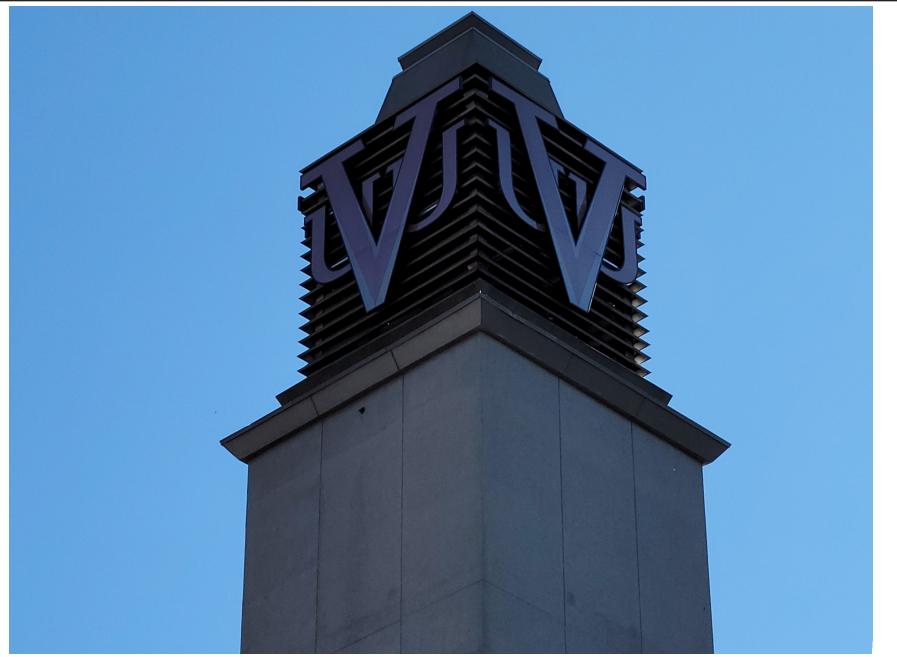
North and West Exterior Detail

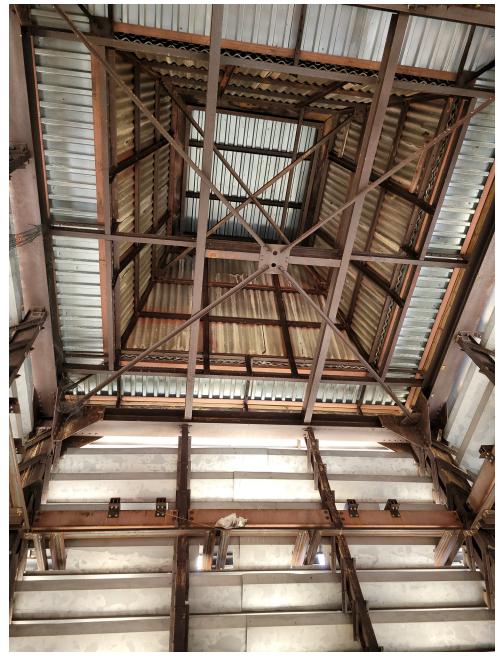
View of Interior Peak

The peak of the tower is capped with an steel structure cap with aluminum louvers. Before installation of the signage, a number of these had been damaged but are concealed by the signage.

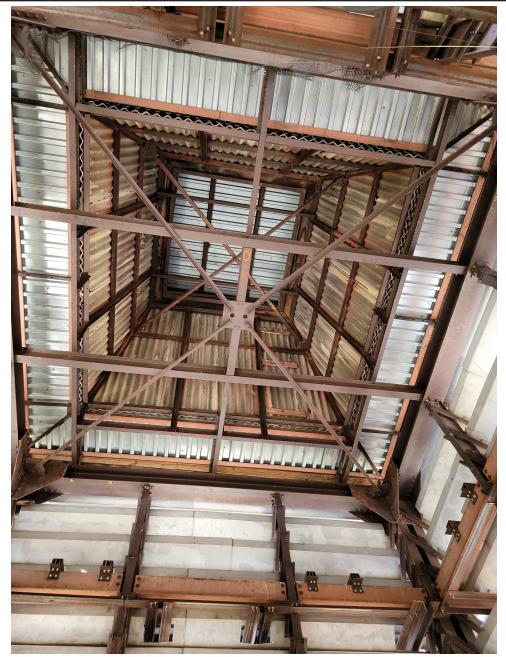
View of Interior Peak
