Staff Report
City of Richmond, Virginia
Commission of Architectural Review

1. COA-111519-2022	Final Review	Meeting Date: 5/24/2022
Applicant/Petitioner	Anne Grier	
Project Description	Replace an existing rear aluminum fence with a stucco clad masonry wall and metal gate.	
Project Location

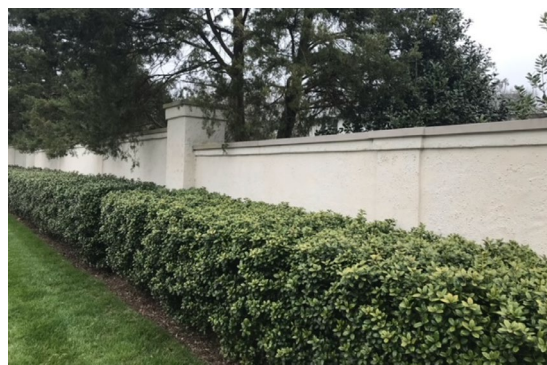
Figure 2. Example stucco wall

Address: 3317 Monument Ave.		
Historic District: Monument Avenue		
High-Level Details: <p>The Applicant proposes to replace an existing black, aluminum rear fence with a 6-foot wall clad in stucco.</p> <p>The stucco color will be “sand” and the texture will match the stucco on the main dwelling’s rear addition, which was constructed in 2015</p> <p>The stucco clad wall will have two black aluminum gates with minimal ornamentation.</p>		
Staff Recommendation	Approval, with Conditions	
Staff Contact	Alex Dandridge, alex.dandridge@rva.gov , (804) 646-6569	
Previous Reviews	In 2015, the Commission approved the construction of a rear addition to the main dwelling.	
Conditions for Approval	<ul style="list-style-type: none"> Staff recommends that the final gate design not include decorative elements, but rather be a simple design, similar to the existing gates, specifications be submitted to staff for review and approval.

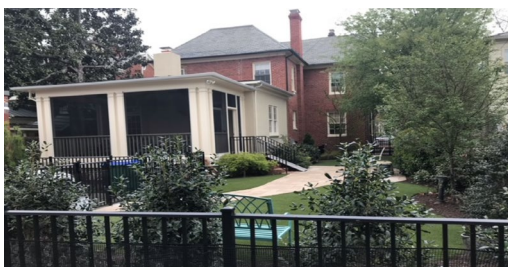
Figure 3. Existing rear aluminum fence. CAR Files, Feb. 2019

Guideline Reference	Reference Text	Analysis
Standards For Site improvements,	5. When considering the design of new fences, remember that some districts, such as Church Hill North and Union Hill,	The applicant is proposing to replace an existing black, aluminum, rear fence with a stucco clad wall, which will be a simple design
