Staff Report City of Richmond, Virginia

Commission of Architectural Review

2. COA-111537-2022	Final Review Meeting Date: 5/24/2022	
Applicant/Petitioner	David Gordon - VUU	
Project Description	Retain four internally illuminated wall signs on the Belgian Building Tower.	
Project Location		
Address: 1500 N. Lombardy	1203 School Road	
Historic District: Belgian Building		
High-Level Details:		
The applicant requests permission to retain one internally illuminated sign on each of the four faces of the bell tower of the Belgian Building.	Belgian Building 1500 Belgian Building 1500 Belgian Building 1500 Belgian Building Belgian Building Belgian Building Belgian Building Belgian Building Belgian Building Belgian Belgian Building Belgian Building Belgian Building Belgian Building Belgian Building Belgian Building Belgian Belgian Building Belgian Building Belgian Bel	
 Each sign is approximately 300 square feet and mounted to the bell tower louvers structure. 	2131	
 This application is the result of an enforcement action, as the applicant has already installed the signs without received a Certificate of Appropriateness (COA). 	N 0 0.01 0.03 1217

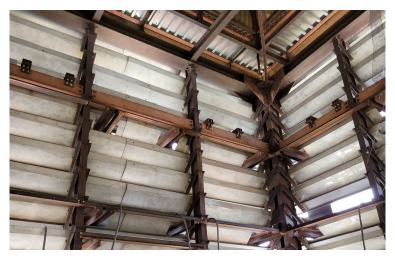
Flat Wall Signs, pg. 74	Flat wall signs are wooden or metal sign panels applied directly to a building façade when a storefront cornice is not present. Generally, these signs are intended to be viewed from a moderate distance. Flat wall signs should be designed to enhance the façade by blending with the architectural features of the building. They should not be merely applied to the surface of the building, nor should they cover or obscure important architectural elements.	The signs do not meet the Guidelines for flat wall signs. Most notably, the installed signs obscure important architectural elements of the building, namely the louvered belfry. The signs are applied directly to a character-defining feature of the building and greatly detract from the overall architectural character of the building. Additional information provided with this submission indicates that the louvers have been cut to accommodate the installation of the signs, damaging this historic feature (see Figure 5).

Figure 5. Sign connection to the bell tower, as shown from the interior.

Staff Recommendation	Denial of the request for the following reasons:	
	 The proposed signage does not meet the guidelines for scale, size, and illumination; and The sign is installed in a way that damages and obscures a character defining feature of the building. 	
Staff Contact	Alyson Oliver, <u>alyson.oliver@rva.gov</u> , 804-646-3709	
Previous Reviews	October 2019 – VUU applied to CAR for a COA to install internally illuminated signs on the louvered portion of the Belgian Building tower.	
	November 2019 - The applicant withdrew the request prior to the November CAR meeting.	
	January 2020 - A Stop Work Order was issued because the signs were installed without the proper permits. A Notice of Violation was issued by CAR and Zoning for installation of the signs without a COA and for the size of the signage.	
	February 2020 - VUU applied to CAR for a COA to keep the signs, as installed. At the February 2020 meeting, CAR denied the COA
