Commission of Architectural Review

1. COA-129910-2023	Final Review	Meeting Date: 5/23/2023
Applicant/Petitioner	Brandi Battle-Brown	
Project Description	Install a mural on a previously painted masonry wall of a mixed-use building.	
Project Location		
Address: 23 W Marshall Street		
Historic District: Jackson Ward		
High-Level Details: Applicant proposes to install a mural on previously painted brick wall of a mixed-use building.		
Staff Recommendation	Approval, with Conditions	
Staff Contact	Samantha Lewis, Samantha.lewis@rva.gov , 804-646-5207	
Previous Reviews	None.	
Conditions for Approval	<ul style="list-style-type: none"> Installation of the new mural is to stay within the boundaries of the previously painted brick.

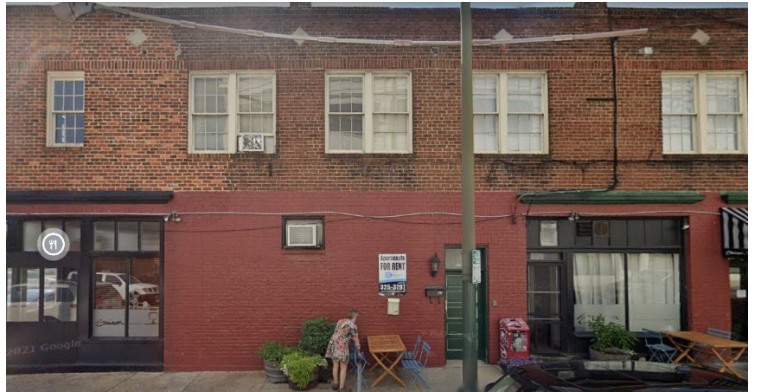
Figure 2. Elevation on North Adams

<p>Standards for Signage, p. 75, #1</p>	<p><i>Adding a mural to a previously-painted, non-primary elevation of a contributing building will be considered on a case-by-case basis.</i></p>	<p>The building is not considered contributing to the Jackson Ward Historic District. The building features a shaped parapet façade wall, a large center window that features 4/4 and 8/8 center window with matching transoms above. Above the center window is a brick arch with a keystone ornamentation with a center diamond made of brick. The bottom half of the building features a traditional storefront that wraps the corner and red painted brick. The mural will be located along North Adams Street on the already painted brick.</p>
<p>Standards for Signage, p. 75, #2</p>	<p><i>Murals painted on primary facades are not permitted.</i></p>	<p>The proposed mural will be painted on a secondary façade, the elevation facing North Adams Street.</p>

<p>Standards for Signage, p. 65, #4</p>	<p><i>A mural should not obscure or distort the historic features of a building.</i></p>	<p>Staff notes there are no defining features on the elevation facing North Adams.</p>
<p>Standards for Signage, p. 75, #5.</p>	<p><i>Murals should be in compliance with the general signage requirements for Old and Historic Districts, where applicable.</i></p>	<p>Staff notes that this mural is not considered a sign by the underlying zoning. <u>Staff recommends approval of the mural with the condition the new mural stays within the boundaries of the previously painted brick.</u></p>
