### 10. COA-086192-2021

### 2012 West Grace Street

STAFF REPORT

#### PROJECT DESCRIPTION Alter roof form of a rear carriage house.

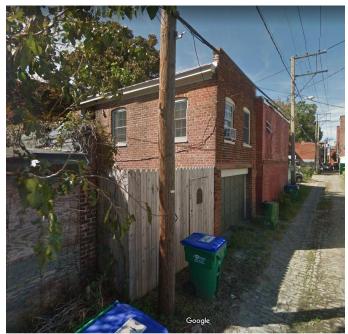
Figure 1. 2012 W. Grace St, carriage house, 2016 Google streetview image.

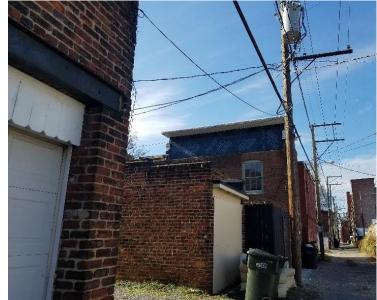
- The applicant requests permission to retain an altered roof on a two-story rear carriage house.
- In January 2021, staff observed construction of a new roof on the carriage house without approval from the Commission of Architectural Review and issued a notice of violation. Property maintenance also issued a stop work order since the applicant did not obtain a building permit.

Figure 2. 2012 W. Grace St, carriage house, current view.

- the applicant return the roof to its original height and configuration and reinstall the decorative trim piece and box gutter and that all replacement materials match the original in design, color, profile, and material
- a waterproofing treatment not be used on the historic masonry
- the applicant use a mortar that replicates the historic mortar to prevent further damage to the historic bricks; consult the National Park Service Technical Preservation Brief #2: *Repointing Mortar Joints in Historic Masonry Buildings*; and consider ways to minimize the appearance of the new mortar

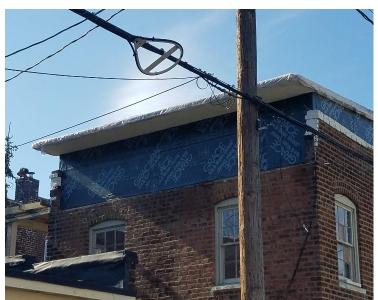
- The applicant has also removed a number of brick courses for waterproofing, and removed a decorative trim piece with a box gutter.

Figure 4. 2012 W. Grace St, carriage house, current roof form. .

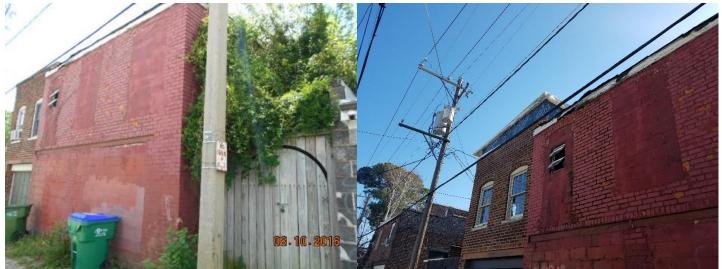
Figure 5. Assessor photograph for 2010 W. Grace St. 2016 W. Grace Street carriage house on the left.

Figure 6. 2012 W. Grace St, carriage house, current roof form.

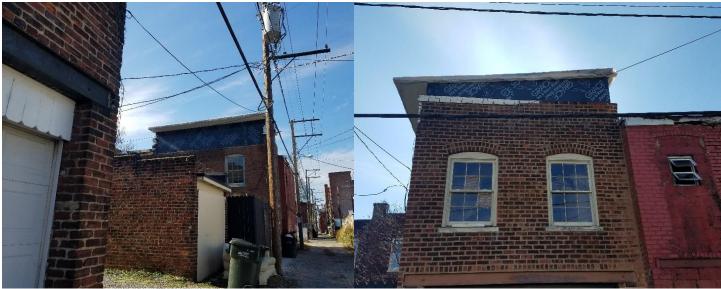
Figure 7. 2012 W. Grace St, carriage house, current roof form.

Figure 8. 2012 W. Grace St, carriage house, new cantilever.
